Arborist Report

TO: Adam Merrill
SITE: St. Edwards Park Ball-field
RE: Tree Retention and Protection Report
DATE: May 6, 2016
UPDATED: August 5, 2016
PROJECT ARBORISTS: Katherine Taylor
ISA Certified Arborist PN-8022A
ISA Qualified Tree Risk Assessor

Summary

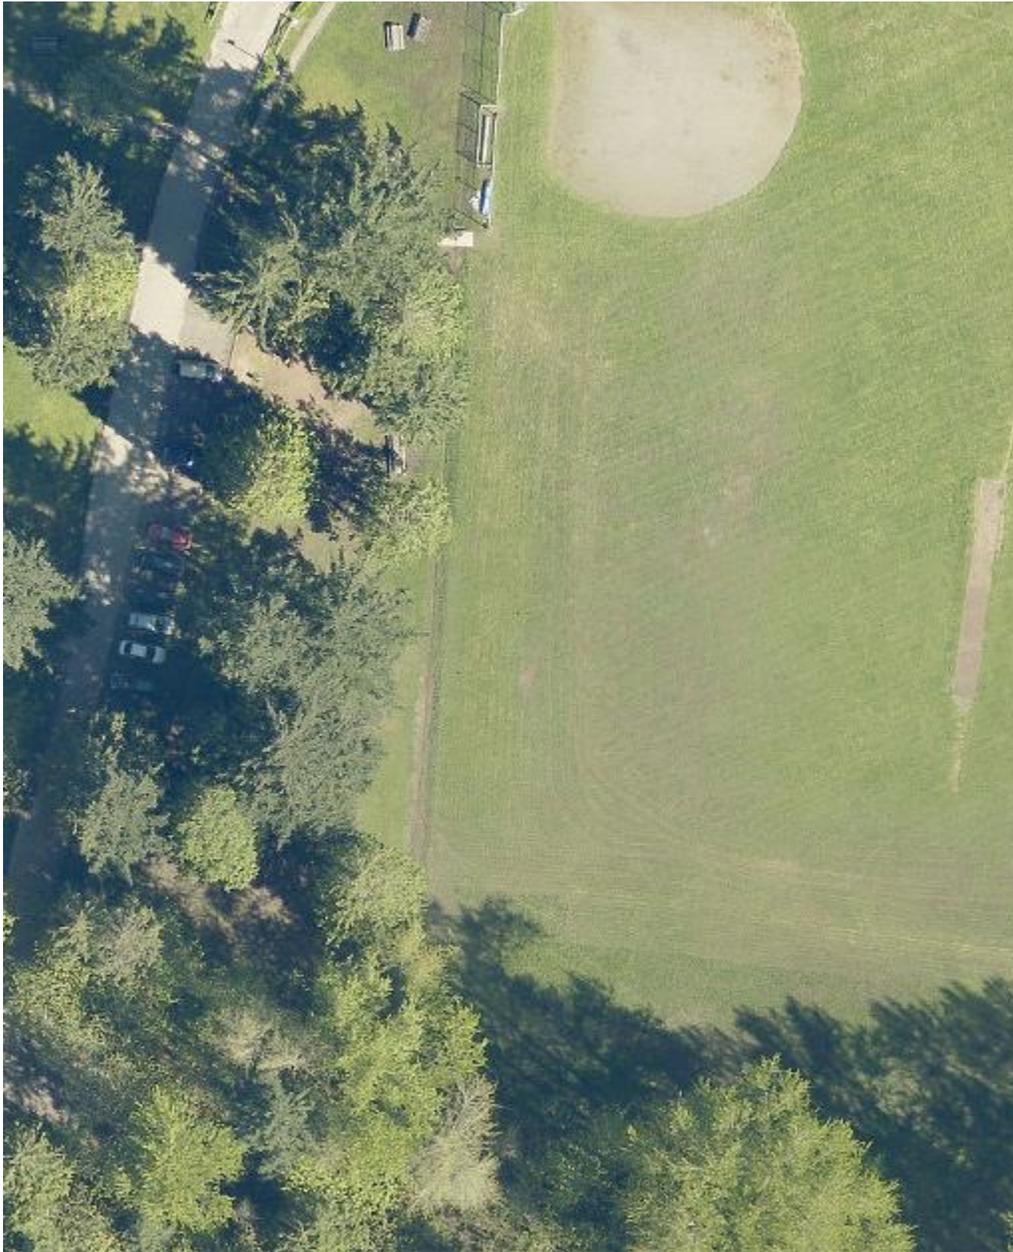
Construction specific to the ball-field does not appear to fall within the critical root zone of any trees. Some of the construction to install pervious paths around the perimeter of the ball-field and between the west parking lot and ball-field does fall within or very near to critical root zones of trees 502 through 509, 516 through 520 and trees 534 through 537.

Photo 1: Aerial view of the west side of the field where installation of permeable paths, gravel paths, and parking improvement is planned within, and around the CRZs of the trees.

To construct paths, consider using a pneumatic excavator, preferably an Air Spade or Air Knife brand, both of which have been designed specifically for use around tree roots, to perform all excavation occurring near trees 501 through 520 and trees 534 through 537. Pneumatic excavators use pressurized air to remove soil around tree roots protecting those roots from significant damage. Limit root pruning to the extent possible. As roots are encountered during excavation, apply gravel under, around, and over the top of the roots. All work and root pruning within and at the edge of the Tree Protection Fencing Zones should be done in the presence of a qualified arborist. A specification for pneumatic excavation is attached. It is best that pneumatic excavation be done by an experience professionals. Several arborists in the area have this equipment and are experienced in these methods.

Construction for the paths in this area should be planned carefully to minimize traffic of heavy equipment in the area. Any heavy excavation equipment should not be used from within the CRZ of any trees unless the soils are protected from the load. If excavators are chosen for use in this area, use a flat bucket to lower the grade and have one person spotting for roots. Any roots over 1.5 inches in diameter encountered should not be torn, instead they should be cut using a sharp saw. Using an excavator is not the recommended method of excavation in this area.

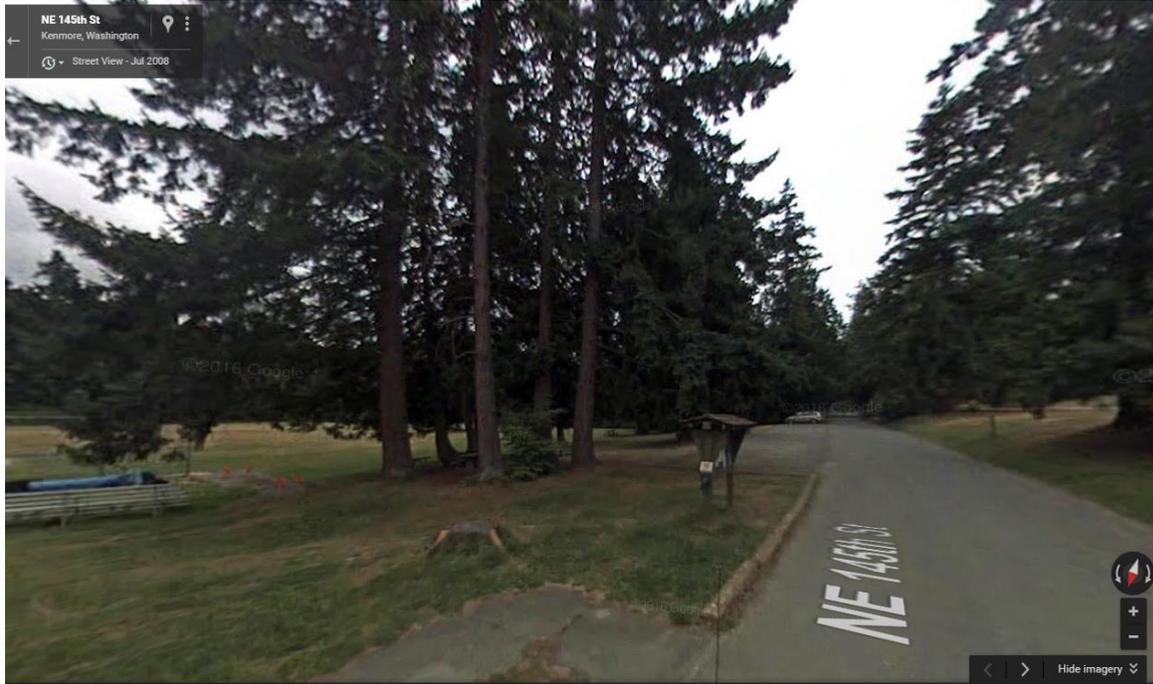
Photo 2: Area adjacent to parking lot where pervious paths are planned within the critical root zone.
Source: Google Maps

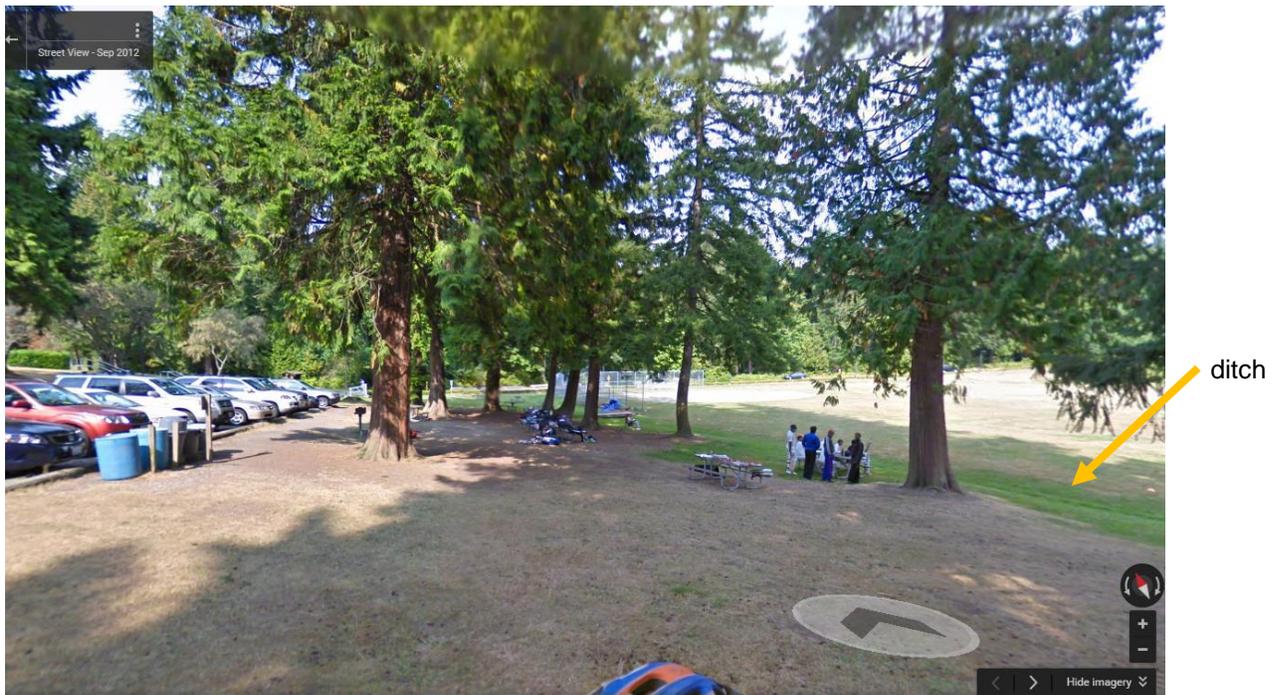
Photo 3: Another view of area adjacent to parking lot where pervious paths are planned within the critical root zone. Note that pervious pavement will also be installed around the perimeter of the new ball-fields over-top of the existing ditch.
Source: Google Maps
