March 25, 2022

Re: Arborist Assessment – 61st Ave NE Sidewalk Project

The Watershed Company Reference Number: 211037.2

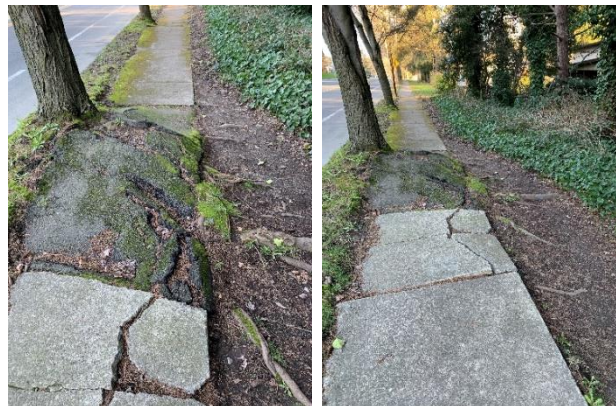
This tree is a red maple (*Acer rubrum*). It is approximately 50 feet tall, has a DBH of 22.1 inches and an average canopy radius of 21 feet. This tree is in *Fair* condition and is located in a narrow planting strip as wide as the trunk and it has an uncorrected lean over the road. The sidewalk has been replaced with asphalt which is lifting, cracking, and breaking and is hazardous for pedestrians and unnavigable for wheelchairs and the visually impaired. Pedestrians have been traveling around the uneven sidewalk, further damaging surface roots as well as causing soil compaction. Approximately 70% of the roots are covered by impermeable surfaces. While the narrow variety of this species is listed as an approved street tree per the City of Kenmore Street Tree List, this is not a narrow variety. Per our inventory with the City of Edmonds, we have found that red maple is a notoriously shallow rooting species that commonly conflicts with and uplifts sidewalks (Rindels 1995) and if retained, this problem will likely persist with the new sidewalk. Bridging over the roots or simply replacing the sidewalk would be a temporary solution. Therefore, the recommended action is to remove the tree.

Figure 2. Image of significant Tree #101 that should be removed.

Advantages for Removal: Eliminate the risk of further and future sidewalk damage.

Disadvantages for Removal: Loss of canopy coverage.

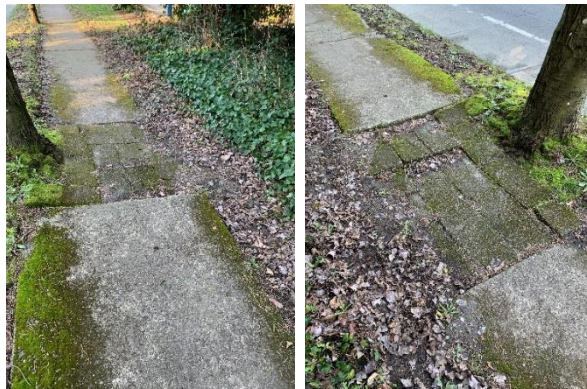
This tree is a red maple (*Acer rubrum*). It is approximately 50 feet tall, has a DBH of 15.4 inches and an average canopy radius of 15 feet. This tree is in *Good* condition and located in a narrow, 1.5-foot planting strip. The tree has an uncorrected lean over the road. The sidewalk has been replaced with cement pavers and it appears that the pavers have settled, causing some damage to the root collar (the area of transition from the roots to the stem). Approximately 70-percent of

the roots are covered by impermeable surfaces. While the narrow variety of this species is listed as an approved street tree per the City of Kenmore Street Tree List, this is not a narrow variety. Per our inventory with the City of Edmonds, we have found that red maple is a notoriously shallow rooting species that commonly conflicts with and uplifts sidewalks (Rindels 1995) and although the pavers currently do not have substantial uplift from the roots, it is only a matter of time. If this tree is retained, then bridging over tree roots or replacing the sidewalk would be a temporary solution and would eventually need to be repaired again. Therefore, the recommended action is to remove the tree.

Figure 3. Pavers over the root system of Tree #102.

Advantages for Removal: Eliminate the risk of further and future sidewalk damage.

Disadvantages for Removal: Loss of overall canopy coverage.

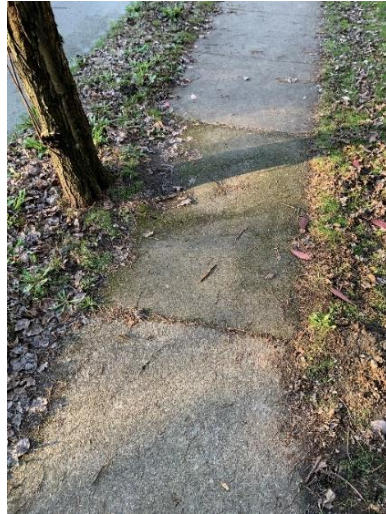
This tree is a red maple (*Acer rubrum*). It is approximately 50 feet tall, has a DBH of 9.3 inches and an average canopy radius of 10 feet. This tree is in *Good* condition and is located in a two-foot planting strip. The sidewalk has a small crack starting to form, indicating that the roots are pushing against the asphalt. There is minor sidewalk lift with visible recent repairs.

Approximately 70-percent of its roots are covered by impermeable surfaces. While the narrow variety of this species is listed as an approved street tree per the City of Kenmore Street Tree List, this is not a narrow variety. Per our inventory with the City of Edmonds, we have found that red maple is a notoriously shallow rooting species that commonly conflicts with and uplifts sidewalks (Rindels 1995) and if retained, this problem will likely persist with the new sidewalk. Bridging over the roots or simply replacing the sidewalk would be a temporary solution. Therefore, the recommended action is to remove the tree.

Figure 4. Tree #103 whose trunk is abutting against the existing sidewalk, resulting in minor uplift.

Advantages for Removal: Eliminate the risk of further and future sidewalk damage.

Disadvantages for Removal: Overall loss of canopy coverage.

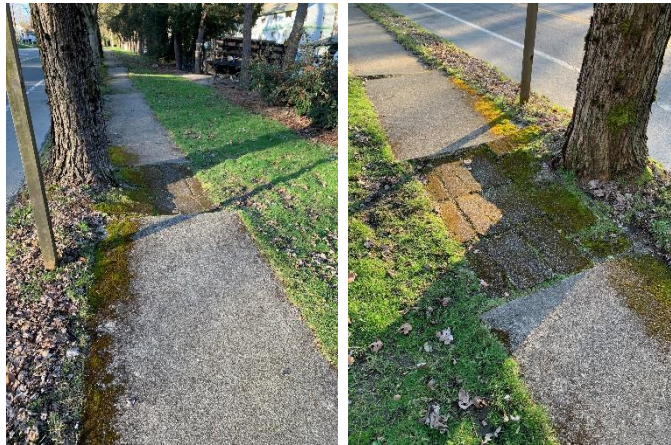
This tree is a red maple (*Acer rubrum*). It is approximately 60 feet tall, has a DBH of 21.9 inches with co-dominant stems at eight feet off the ground and an average canopy radius of 13 feet. This tree is in *Fair* condition and is located in a narrow planting strip that is the same width as the tree's diameter. This tree has co-dominant (2) stems about eight feet up from the ground. The trunk and root system are pushing against both the sidewalk and the street curb. Pavers are sinking which is causing a tripping hazard for pedestrians and obstacles for wheelchairs and the visually impaired. There is also a street sign approximately 2.5 feet from the trunk and replacement of this post may result in damage to major roots. Approximately 60-percent of the root system is covered by impermeable surfaces. While the narrow variety of this species is listed as an approved street tree per the City of Kenmore Street Tree List, this is not a narrow variety. Per our inventory with the City of Edmonds, we have found that red maple is a notoriously shallow rooting species that commonly conflicts with and uplifts sidewalks (Rindels 1995) and if retained, this problem will likely persist with the new sidewalk. Bridging over the roots or simply replacing the sidewalk would be a temporary solution. Therefore, the recommended action is to remove the tree.

Figure 5. Trunk of Tree #104 directly impacting the existing sidewalk pavers.

Advantages for Removal: Eliminate the risk of further and future sidewalk damage.

Disadvantages for Removal: Overall loss of canopy coverage.

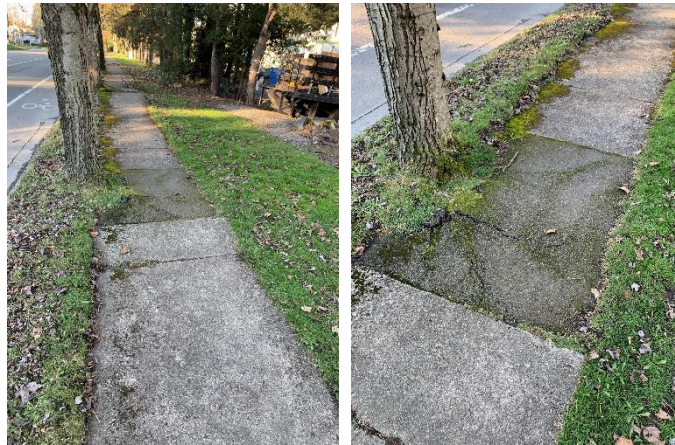
This tree is a red maple (*Acer rubrum*). It is approximately 45 feet tall, has a DBH of 15 and an average canopy radius of 12 feet. This tree is in *Good* condition and is located in a 2.5-foot planting strip adjacent the street. The sidewalk is cracking due to surface root upheaval. There is minor damage to the root collar due to contact with the asphalt. Approximately 70-percent of the roots are covered by impermeable surfaces. While the narrow variety of this species is listed as an approved street tree per the City of Kenmore Street Tree List, this is not a narrow variety. Per our inventory with the City of Edmonds, we have found that red maple is a notoriously shallow rooting species that commonly conflicts with and uplifts sidewalks (Rindels 1995) and if retained, this problem will likely persist with the new sidewalk. Bridging over the roots or simply replacing the sidewalk would be a temporary solution. Therefore, the recommended action is to remove the tree.

Figure 6. Tree #105 already damaging the newly replaced sidewalk.

Advantages for Removal: Eliminate the risk of further and future sidewalk damage.

Disadvantages for Removal: Overall loss of canopy coverage.

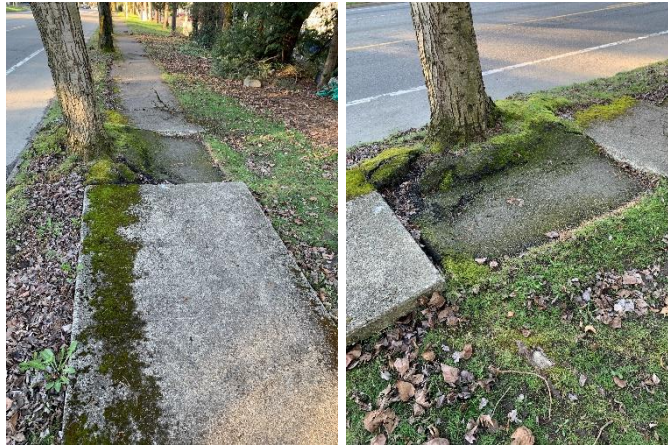
This tree is a red maple (*Acer rubrum*). It is approximately 45 feet tall, has a DBH of 17.4 inches and an average canopy radius of 18 feet. This tree is in *Fair* condition, is located in a two-foot planting strip, and has an uncorrected lean over the road. The asphalt repairs rise above the cement sidewalk at the tree's base and slopes away from the road. This out-slope may be hazardous to pedestrians, wheelchairs and the visually impaired. Approximately 70-percent of its roots are covered by impermeable surfaces. While the narrow variety of this species is listed as an approved street tree per the City of Kenmore Street Tree List, this is not a narrow variety. Per our inventory with the City of Edmonds, we have found that red maple is a notoriously shallow rooting species that commonly conflicts with and uplifts sidewalks (Rindels 1995) and if retained, this problem will likely persist with the new sidewalk. Bridging over the roots or simply replacing the sidewalk would be a temporary solution. Therefore, the recommended action is to remove the tree.

Figure 7. Major damage to the existing sidewalk from the shallow root system of Tree #106.

Advantages for Removal: Eliminate the risk of further and future sidewalk damage.

Disadvantages for Removal: Overall loss of canopy coverage.

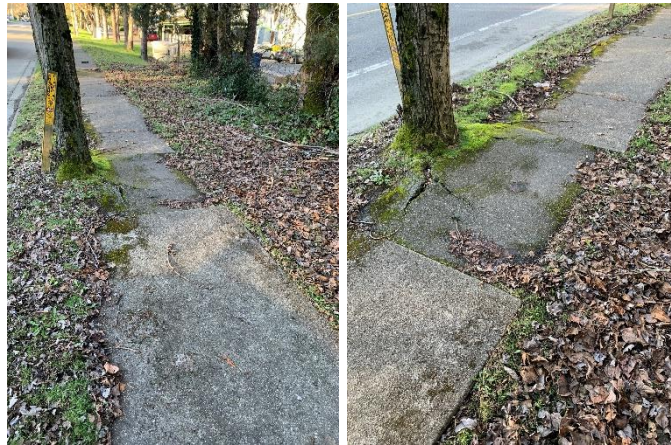
This tree is a red maple (*Acer rubrum*). It is approximately 35 feet tall, has a DBH of 14.3 inches and an average canopy radius of 16 feet. This tree is in *Fair* condition and is located in a planting strip over a natural gas pipeline (see picture below). Maintenance of the sidewalk would likely result in severe damage to critical roots. Given its age, this tree may not recover from those damages to its roots. There is major cement sidewalk lift with visible damage to past asphalt repairs. The asphalt that replaced the cement sidewalk is sinking away from the road, causing a tripping hazard. It also has an uncorrected lean over the road and an unbalanced canopy. Approximately 75-percent of its roots are covered by impermeable surfaces. Similar to the reasons identified to the trees above, this tree should be removed to prevent the continuous need for sidewalk repair and should be replaced with a more suitable species.

Figure 8. Trunk of Tree #107 abutting against the existing sidewalk causing significant damage.

Advantages for Removal: Eliminate the risk of further and future sidewalk damage.

Disadvantages for Removal: Overall loss of canopy coverage.

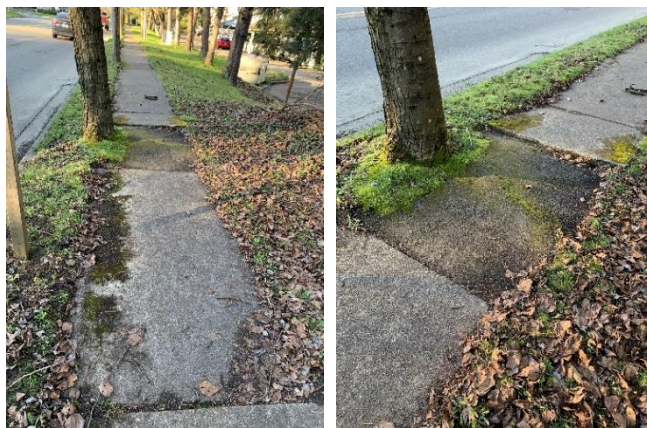
This tree is a red maple (*Acer rubrum*). It is approximately 35 feet tall, has a DBH of 15.8 inches and an average canopy radius of 21 feet. This tree is in *Fair* condition and is located in a planting strip approximately two feet wide. It has an uncorrected lean over the road and has an unbalanced canopy. There is a street sign located in the critical root zone and should be relocated past the drip line of the canopy. The asphalt is cracking and sinking, causing a potential hazard or obstacle for pedestrians, wheelchairs and the visually impaired. Approximately 75-percent of its roots are covered by impermeable surfaces. Similar to the reasons identified for the trees above, this tree should be removed to prevent the continuous need for sidewalk repair and should be replaced with a more suitable species.

Figure 9. Trunk immediately abutting against the existing sidewalk causing significant damage.

Advantages for Removal: Eliminate the risk of further and future sidewalk damage.

Disadvantages for Removal: Overall loss of canopy coverage.

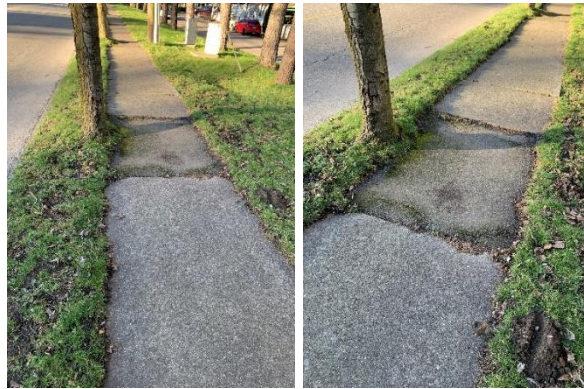
This tree is a red maple (*Acer rubrum*). It is approximately 40 feet tall, has a DBH of 10.8 inches and an average canopy radius of 12 feet. This tree is in *Good* condition and is located in a two-foot planting strip. The asphalt is starting to crack, and it is sinking, causing a hazard and obstacle for pedestrians, wheelchairs and the visually impaired. Approximately 60-percent of its roots are covered by impermeable surfaces. Similar to the reasons identified for the red maples above, this tree should be removed to prevent the continuous need for sidewalk repair and should be replaced with a more suitable species.

Figure 11. Trunk of Tree #110 already abutting against the sidewalk and a small planting strip.

Advantages for Removal: Eliminate the risk of further and future sidewalk damage.

Disadvantages for Removal: Overall loss of canopy coverage.

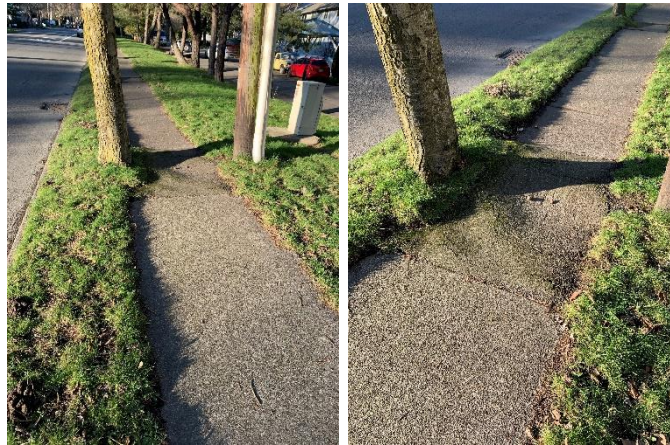
This tree is a red maple (*Acer rubrum*). It is approximately 40 feet tall, has a DBH of 14.4 inches and an average canopy radius of 16 feet. This tree is in *Good* condition and is located in a 2.5-foot planting strip. This tree is directly across the sidewalk from a utility pole and its roots likely extend toward two utility boxes on the ground. Utility boxes and the pole may possibly interfere with the tree, or vice versa. Any maintenance to these utilities may cause significant damage to the root system. Other, smaller trees or shrubs would be a better alternative in this area due to the presence of the utilities. There is minor sidewalk lift with the asphalt cracking, resulting in an uneven surface and an obstacle for wheelchairs and the visually impaired. The roots of this tree are approximately 60-percent covered by impermeable surfaces. Similar to the reasons identified for the red maples above, this tree should be removed to prevent the continuous need for sidewalk repair and should be replaced with a more suitable species.

Figure 12. Trunk of Tree #111 already abutting against the sidewalk with no room within the planting strip.

Advantages for Removal: Eliminate the risk of further and future sidewalk damage.

Disadvantages for Removal: Overall loss of canopy coverage.

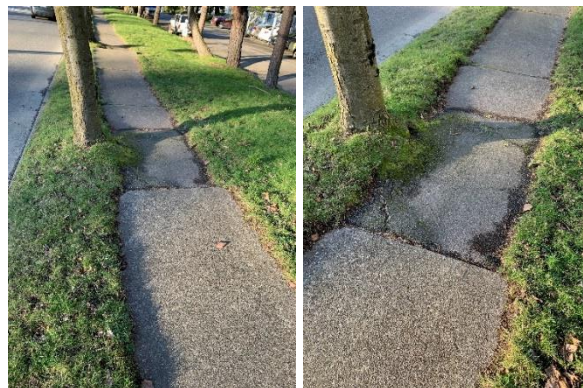
This tree is a red maple (*Acer rubrum*). It is approximately 40 feet tall, has a DBH of 12.1 inches and an average canopy radius of 16 feet. This tree is in *Good* condition and is located in a 2.5-foot planting strip. There are utility lines interfering with the canopy. There is minor sidewalk lift and the asphalt is cracking, causing uneven surfaces, that may be a potential hazard for pedestrians, wheelchairs and the visually impaired. Approximately 60-percent of the roots are covered by impermeable surfaces. Similar to the reasons identified for the red maples above, this tree should be removed to prevent the continuous need for sidewalk repair and should be replaced with a more suitable species.

Figure 13. Trunk and roots causing uplift and damage to the existing sidewalk.

Advantages for Removal: Eliminate the risk of further and future sidewalk damage.

Disadvantages for Removal: Overall loss of canopy coverage.

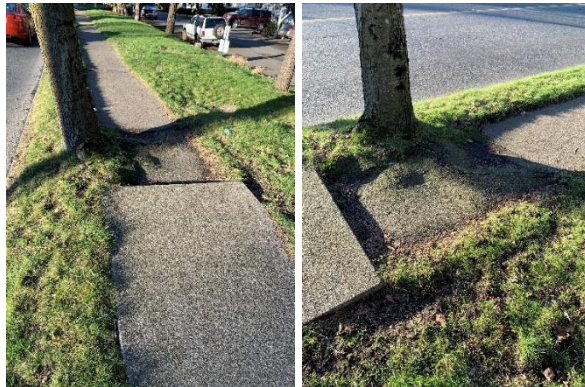
This tree is a red maple (*Acer rubrum*). It is approximately 45 feet tall, has a DBH of 15.5 inches and an average canopy radius of 16 feet. This tree is located in a 2.5-foot planting strip and is in *Poor* condition due to a large amount of included bark at its co-dominant (2) stem union, about eight feet off the ground. There is sidewalk lift of approximately three inches and cracks in the asphalt. The lift and cracks are causing uneven surfaces that may be tripping hazards or obstacles for wheelchairs or the visually impaired. Approximately 60-percent of the roots are covered by impermeable surfaces. This tree has a slight lean over the road. Similar to the reasons identified for the red maples above, this tree should be removed to prevent the continuous need for sidewalk repair and should be replaced with a more suitable species.

Figure 14. Significant damage caused by trunk and root system.

Advantages for Removal: Eliminate the risk of further and future sidewalk damage.

Disadvantages for Removal: Overall loss of canopy coverage.

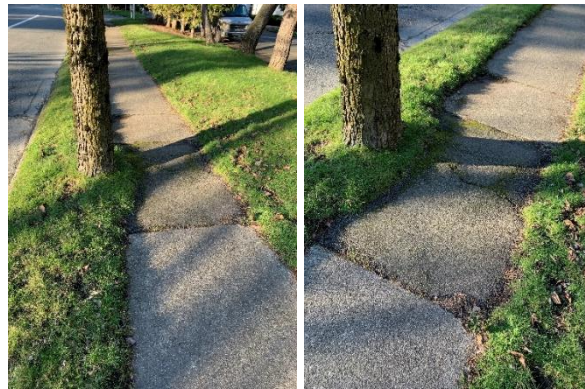
This tree is a red maple (*Acer rubrum*). It is approximately 50 feet tall, has a DBH of 13.6 inches and an average canopy radius of 5 feet. This tree is in *Good* condition and is located in a 2.5-foot-wide planting strip. There is minor sidewalk lift with cracks in the asphalt and may be an obstacle for pedestrians, wheelchairs or the visually impaired. Similar to the reasons identified to the red maples above, this tree should be removed to prevent the continuous need for sidewalk repair and should be replaced with a more suitable species.

Figure 15. Trunk and root system causing damage to the existing sidewalk.

Advantages for Removal: Eliminate the risk of further and future sidewalk damage.

Disadvantages for Removal: Overall loss of canopy coverage.

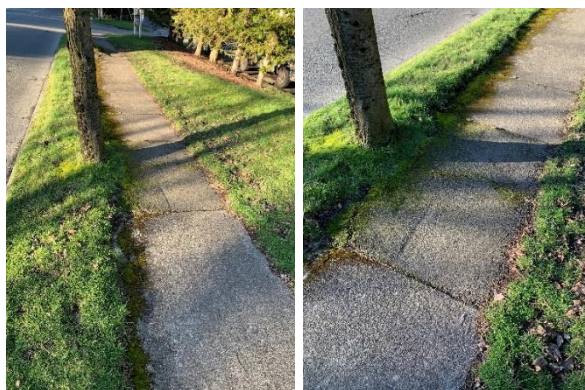
This tree is a red maple (*Acer rubrum*). It is approximately 50 feet tall, has a DBH of 10.4 inches and an average canopy radius of 12 feet. This tree is in *Good* condition and is located in a planting strip approximately 2.5 feet wide. This tree has a slight lean over the road and there are minor cracks and lift in the sidewalk. Approximately 50-percent of the roots are covered by impermeable surfaces and the tree is on a slight incline that slopes toward the road. Similar to the reasons identified to the red maples above, this tree should be removed to prevent the continuous need for sidewalk repair and should be replaced with a more suitable species.

Figure 16. Minor damage caused by the trunk and root system.

Advantages for Removal: Eliminate the risk of further and future sidewalk damage.

Disadvantages for Removal: Overall loss of canopy coverage.

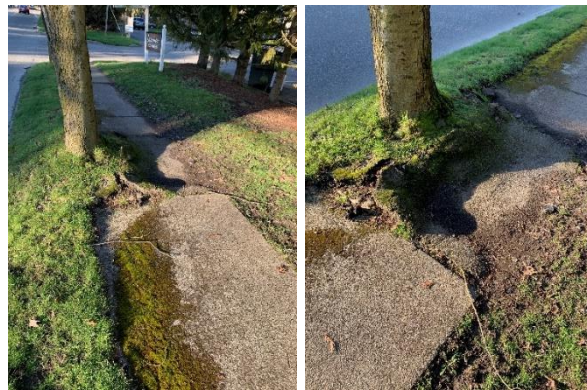
condition, likely due to its conflict with the repaired sidewalk. The root crown sits several inches above ground level which is causing shallow roots to damage the sidewalk and vice versa. This is a possible tripping hazard or obstacle for some users. Approximately 50-percent of the roots are covered by impermeable surfaces. Similar to the reasons identified for the red maples above, this tree should be removed to prevent the continuous need for sidewalk repair and should be replaced with a more suitable species.

Figure 17. Significant damage caused by the existing tree.

Advantages for Removal: Eliminate the risk of further and future sidewalk damage.

Disadvantages for Removal: Overall loss of canopy coverage.

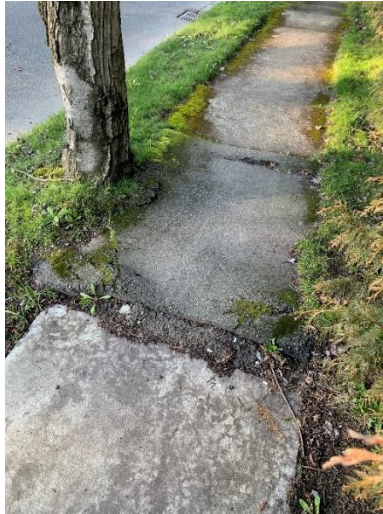
Figure 18. Minor damage to the sidewalk caused by the trunk and the root system.

Advantages for Removal: Eliminate the risk of further and future sidewalk damage.

Disadvantages for Removal: Overall loss of canopy coverage.

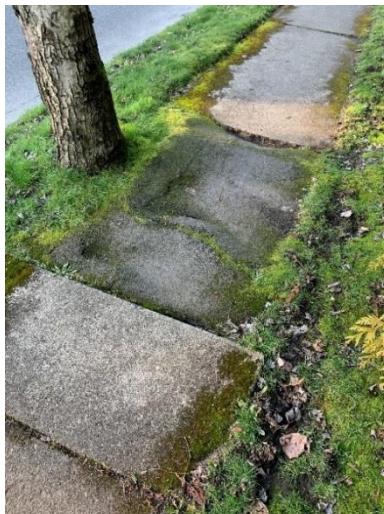
Figure 19. Significant damage caused by the trunk and root system of Tree #118.

Advantages for Removal: Eliminate the risk of further and future sidewalk damage.

Disadvantages for Removal: Overall loss of canopy coverage.

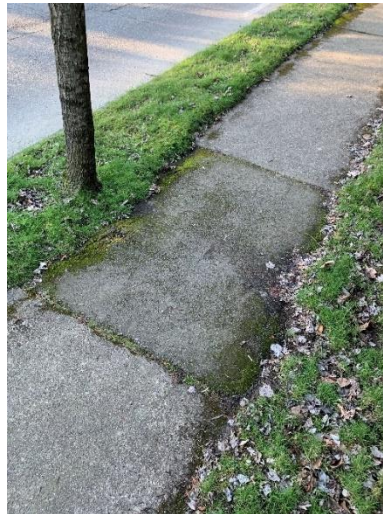
Figure 20. Minor damage to the existing sidewalk.

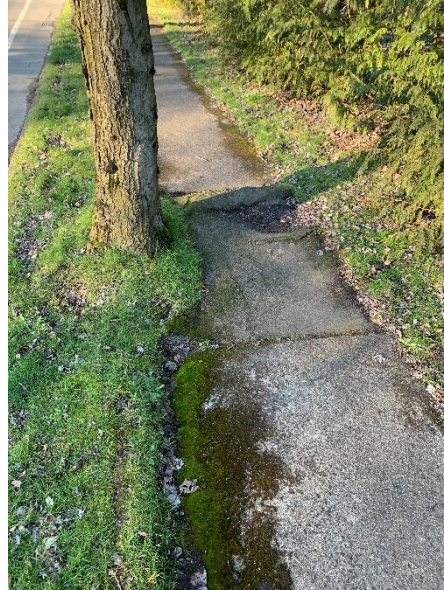
Figure 21. Minor damages caused by the trunk and root system of the subject tree.

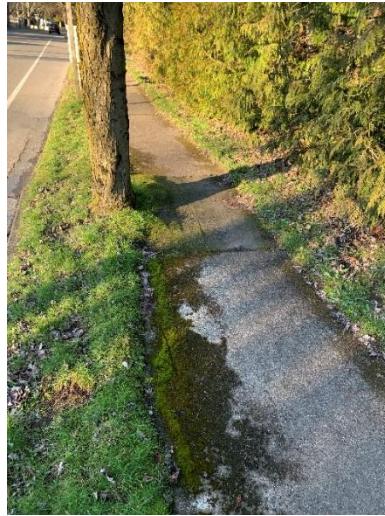
Figure 22. Minor damage caused by the subject tree.

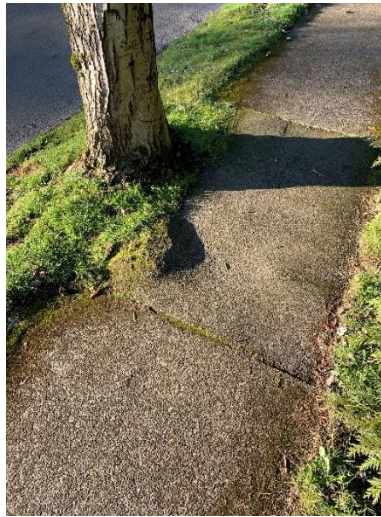
Figure 23. Significant damage resulting from the roots and trunk against the sidewalk.

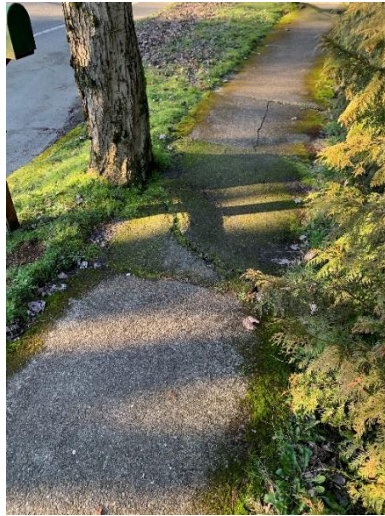
Figure 24. Significant damage to the existing sidewalk from the shallow root system.

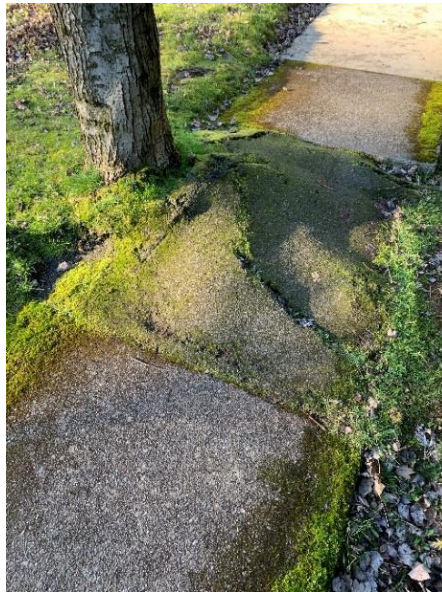
Figure 25. Major damage to the existing sidewalk from the shallow root system.

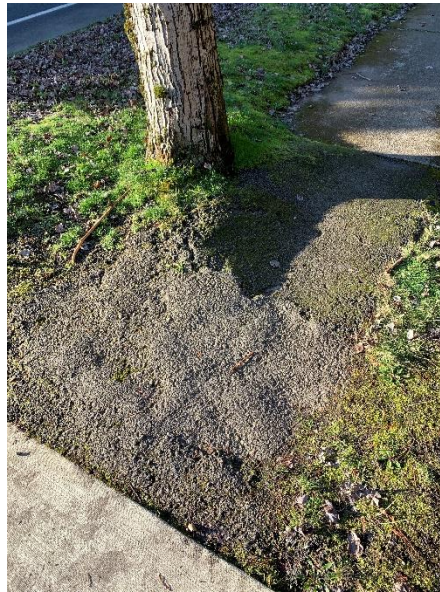
Figure 26. Major damage to the existing sidewalk from the shallow root system.

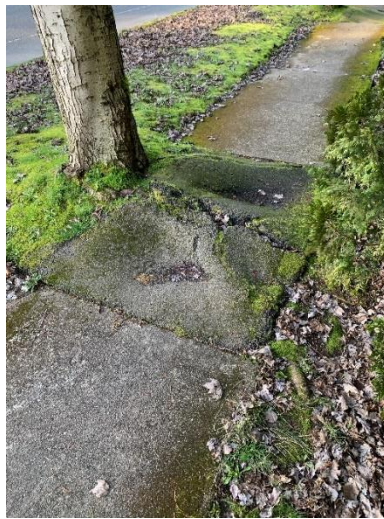
Figure 27. Significant damage to the existing sidewalk from the root system.

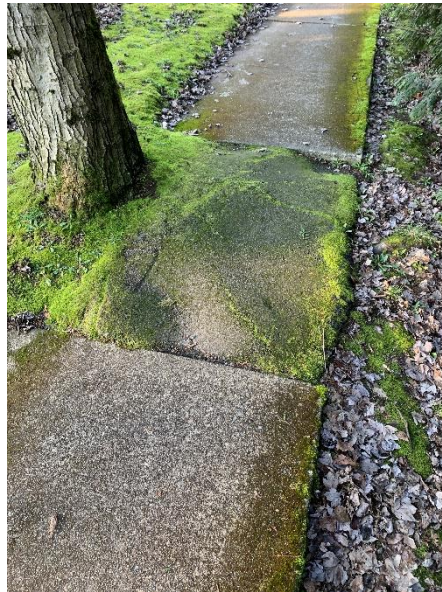
Figure 28. Significant damage to the existing sidewalk.

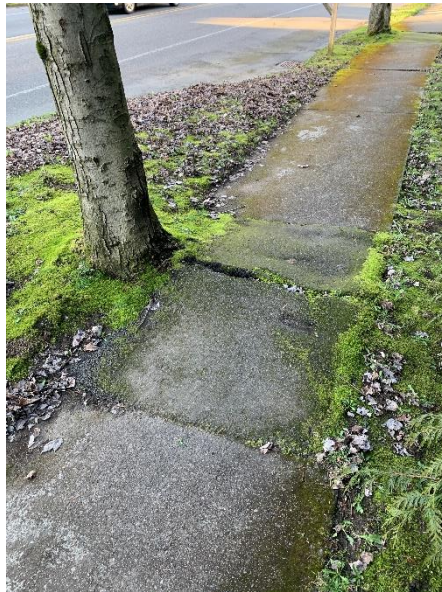
Figure 29. Significant damage to the existing sidewalk.

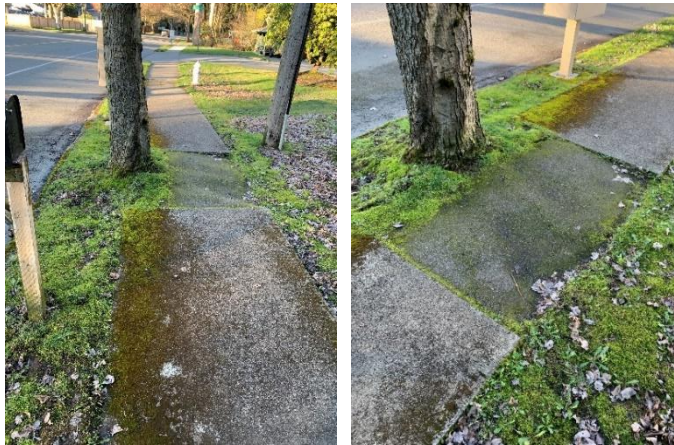
Figure 30. Significant damage to the existing sidewalk from the shallow root system.

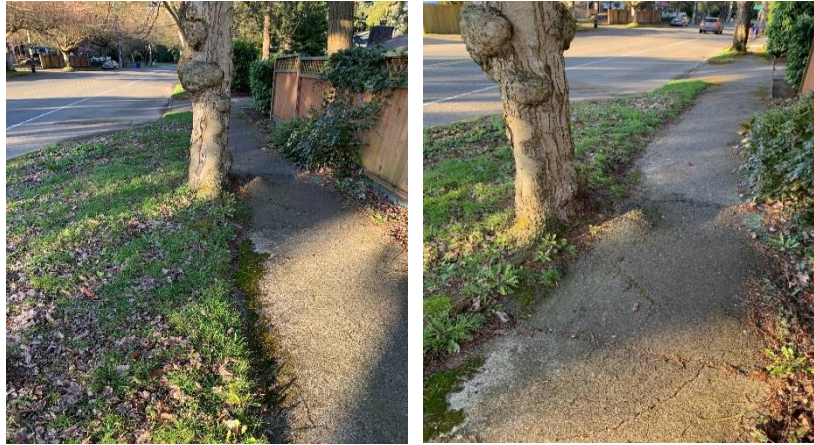
Disadvantages of Alternative Designs 3A and 3B: Eventual sidewalk repair and replacement may be required in the future due to the shallow rooting nature of the species. Galls on the stem may indicate that there are interior defects with the tree that may result in the decline of health.

Figure 31. Multiple large galls on the stem of the tree and the significant damage to the existing sidewalk.

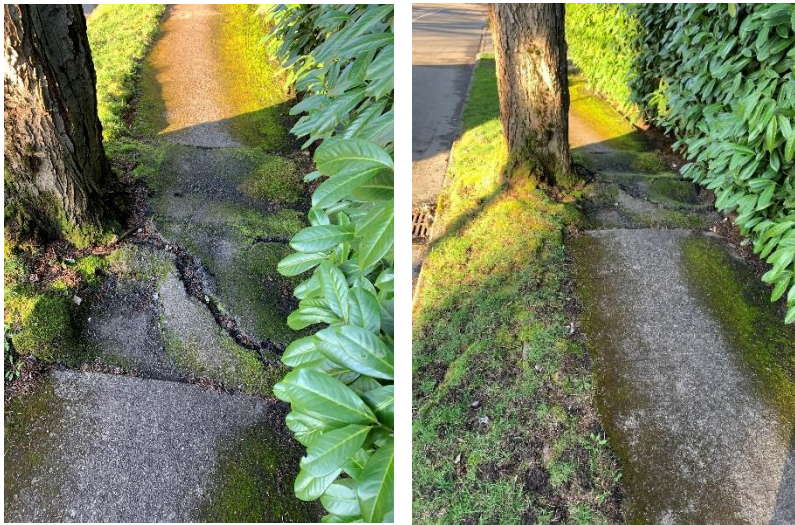
Figure 32. Major damage to the existing sidewalk caused by the shallow rooting system and trunk.

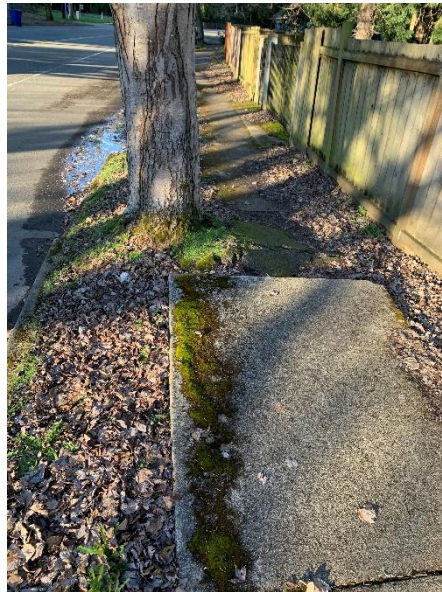
Figure 33. Significant uplift of sidewalk caused by the shallow root system.

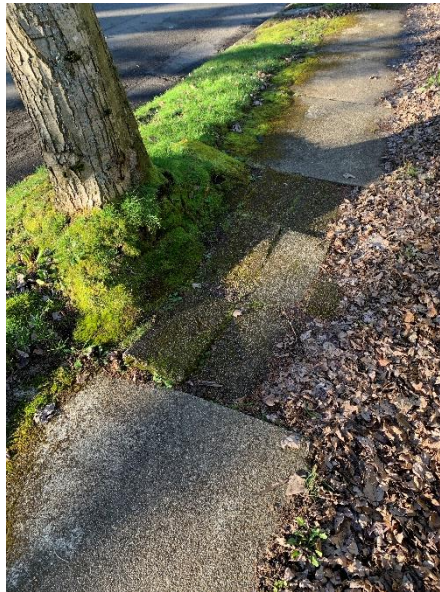
Figure 34. Significant uplift of the pavers that have replaced the old sidewalk.

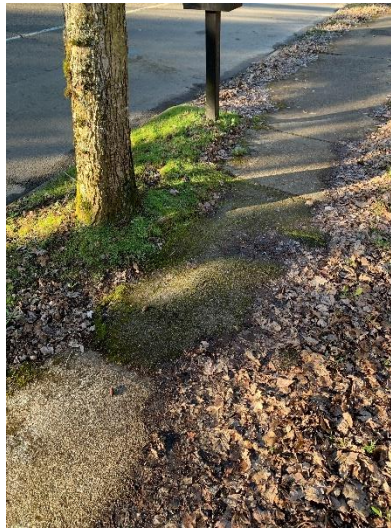
Figure 35. Significant damage to the sidewalk from the root system of the subject tree.

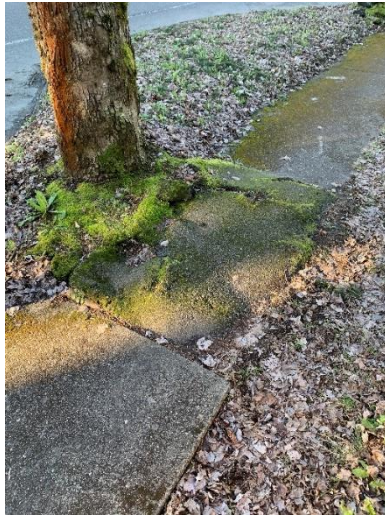
Figure 36. Significant uplift and damage of the existing sidewalk.

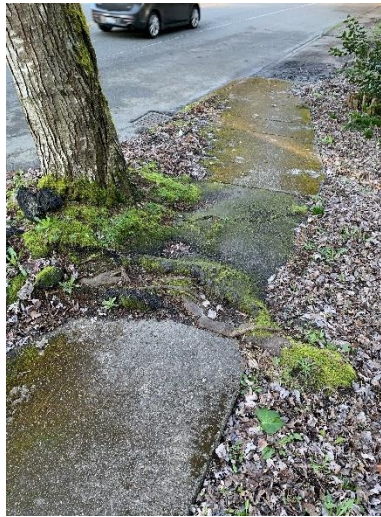
Disadvantages of Alternative Designs 3A and 3B: Eventual sidewalk repair and replacement may be required in the future due to the shallow rooting nature of the species. The damage to the surface roots may prove to be substantial enough that the decline of the tree's health is inevitable and tree removal be required.

Figure 37. Major uplift and damage to the existing sidewalk from the shallow root system.

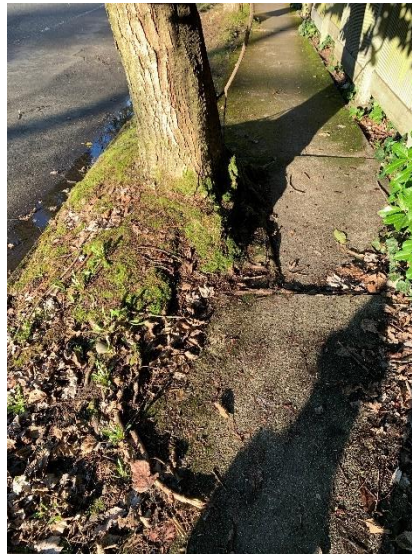
Figure 38. Significant damage to the existing sidewalk creating a hazard.

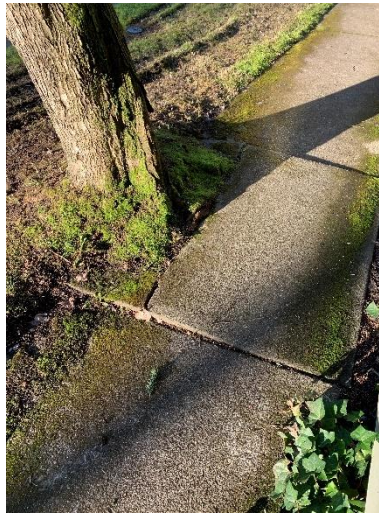
Figure 39. Minor uplift of the existing sidewalk from surface roots.

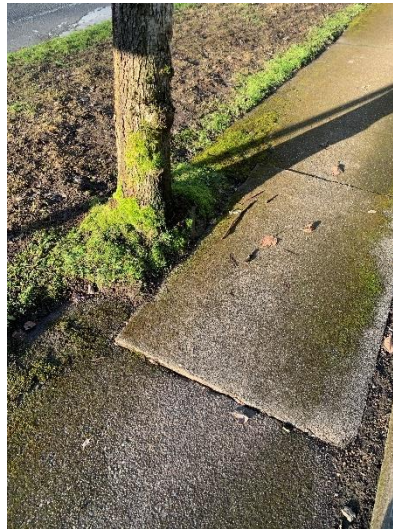
Figure 40. Minor uplift of the existing sidewalk due to surface roots.

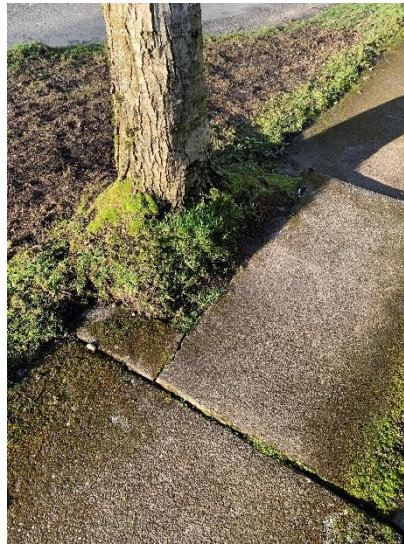
Figure 41. Minor uplift to the existing sidewalk from the surface roots.

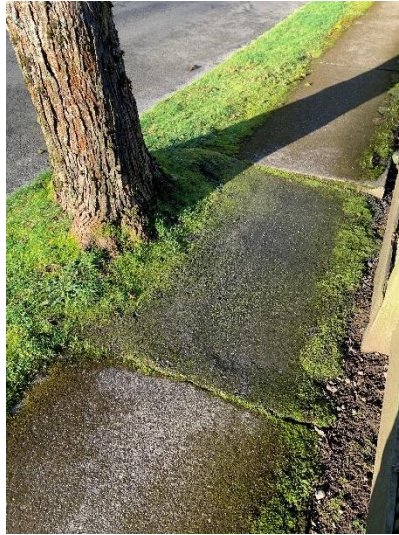
Figure 42. Very minor damage to the existing sidewalk from the trunk and surface roots.

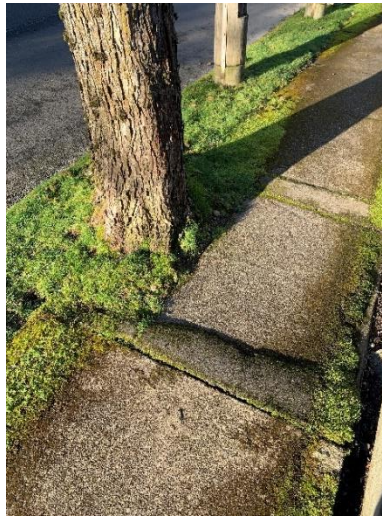
Figure 43. Uplift of the existing sidewalk due to the shallow surface roots.

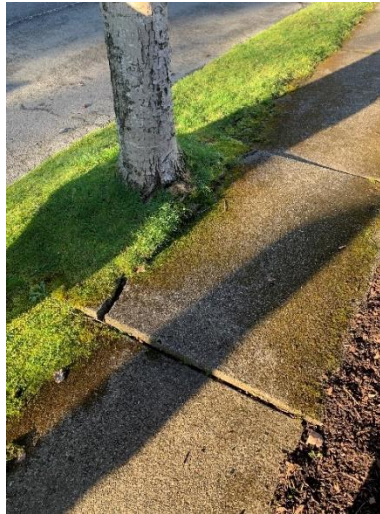
Figure 44. Minor uplift of the existing sidewalk.

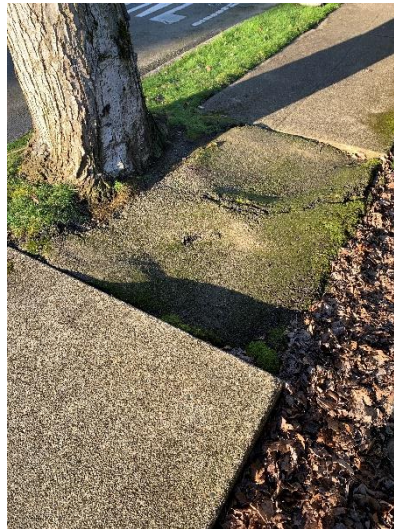
Figure 45. Significant damage to the existing sidewalk.

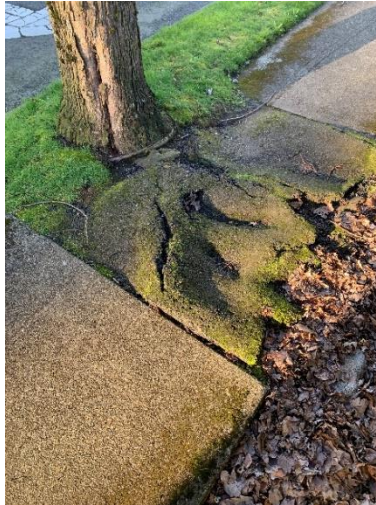
Figure 46. Major damage to the existing sidewalk due to surface roots of the subject tree.

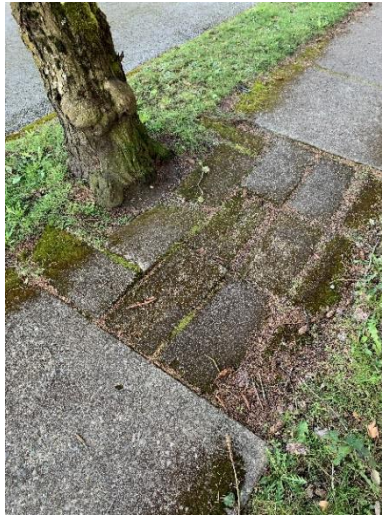
Figure 47. The subject tree is in *Poor* condition and should be removed and replaced with a more suitable species.

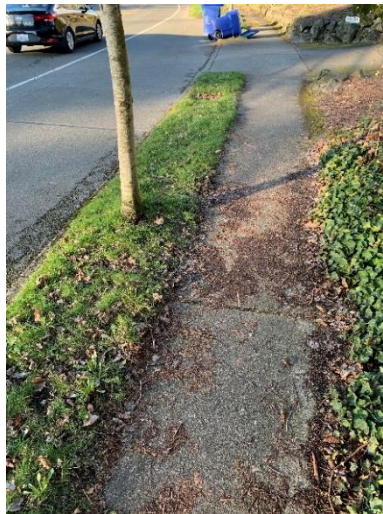
Figure 48. Juvenile subject tree that is not damaging the sidewalk and should be retained.

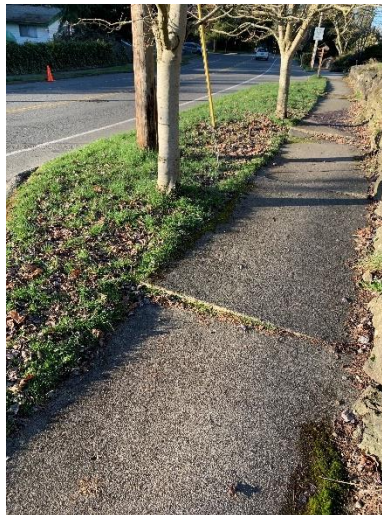
Figure 49. Minor uplift of the existing sidewalk due to surface roots of the subject tree.

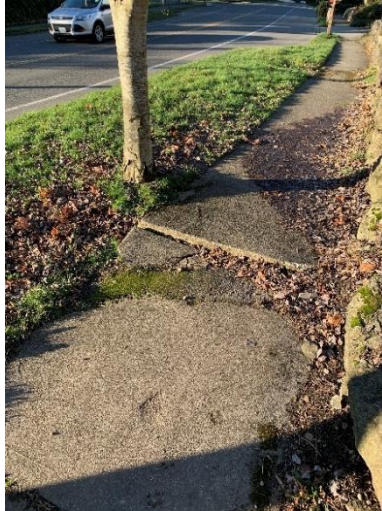
Figure 50. Bridging over the sidewalk would allow for the retention of the tree.

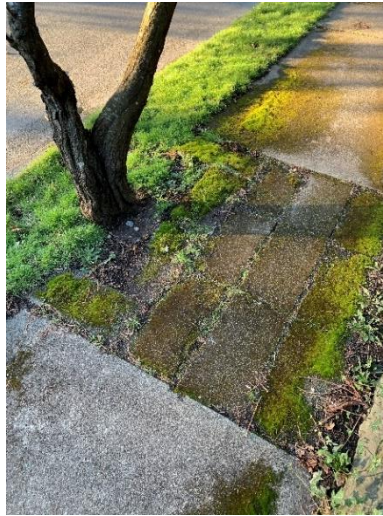
Figure 51. Subject tree in *Poor* health that should be removed and replaced with a more suitable species.

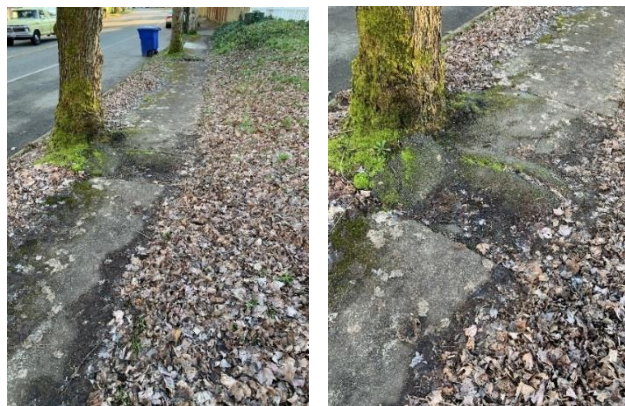
Figure 52. Root system severely impacting the existing sidewalk creating a hazard for pedestrians.

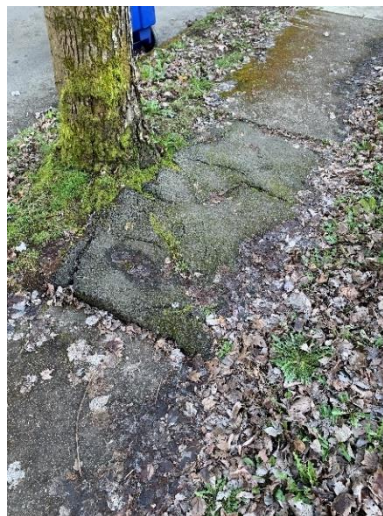
Figure 53. Root system severely impacting the existing sidewalk creating a hazard for pedestrians.

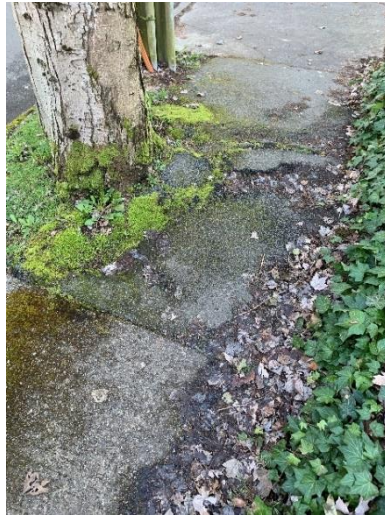
Figure 54. Root system of the subject tree is severely impacting the existing sidewalk.

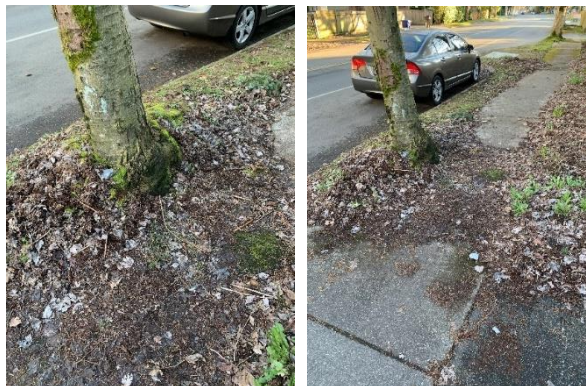
Figure 55. Root system of the subject tree is severely impacting the existing sidewalk.

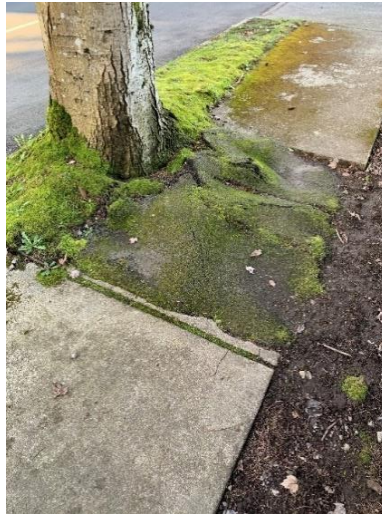
Figure 56. Root system of the subject tree is severely impacting the existing sidewalk.

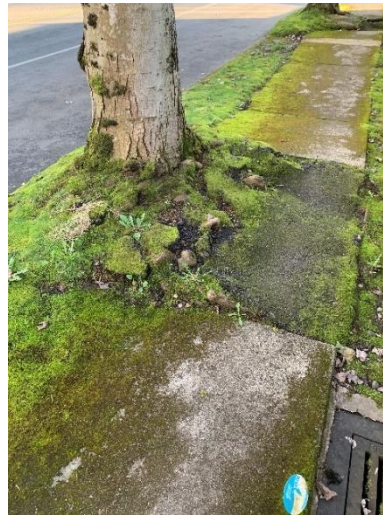
Figure 57. Root system and trunk of the subject tree is severely impacting the existing sidewalk, creating a hazard for pedestrians.

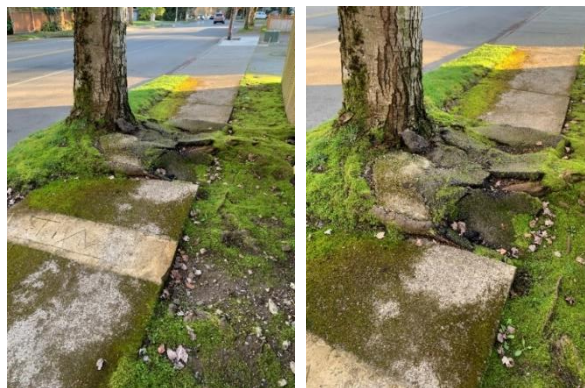
Figure 58. Severe impact to the existing sidewalk caused by the root system of the subject tree.

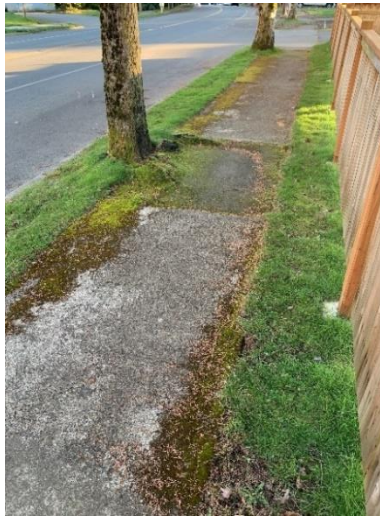
Figure 59. Minor uplift of the existing sidewalk due to the root system.

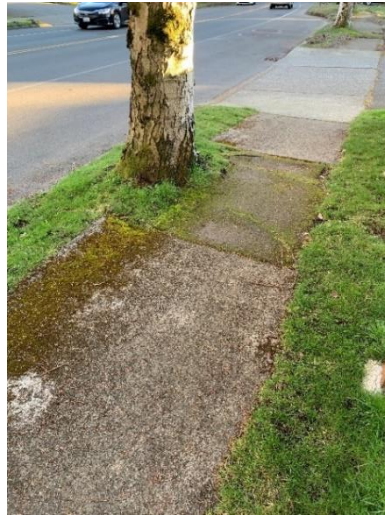
Figure 60. Minor impact on the existing sidewalk due to the root system.

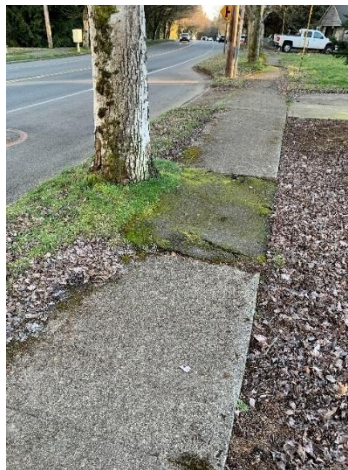
Figure 61. Significant impact to the existing sidewalk caused by the root system of the subject tree.

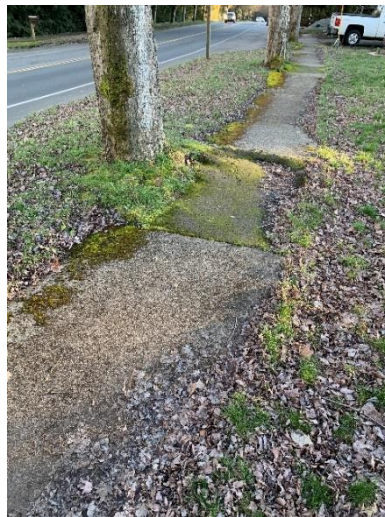
Figure 62. Significant impact to the existing sidewalk due to the root system of the subject tree.

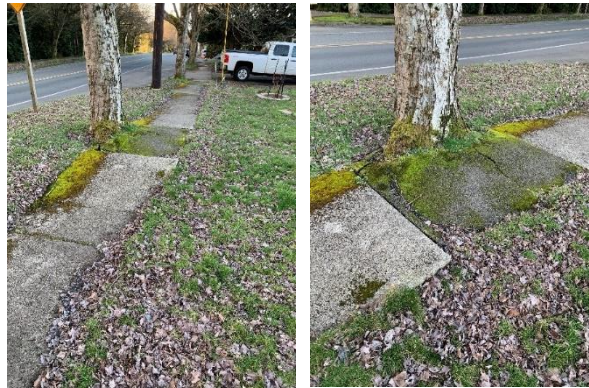
Figure 63. Severe impact to the existing sidewalk caused by the shallow root system.

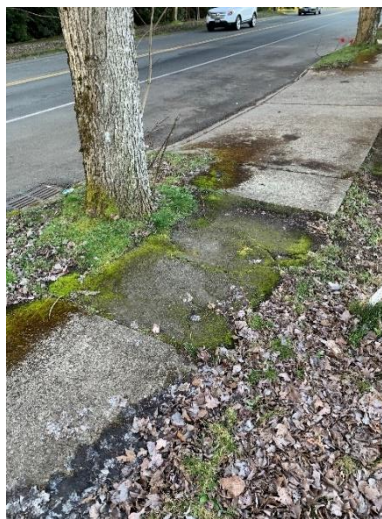
Figure 64. Severe impact to the existing sidewalk caused by the shallow root system.

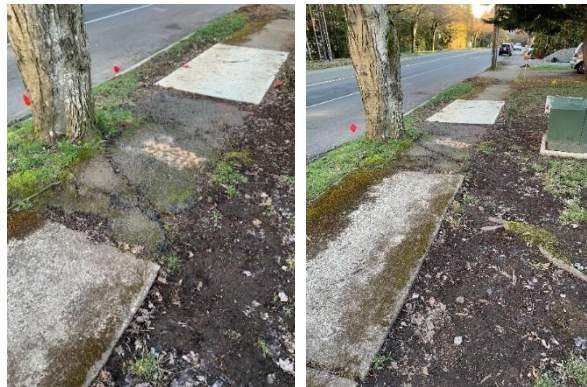
Figure 65. Severe impact to the existing sidewalk caused by the shallow root system of the subject tree.

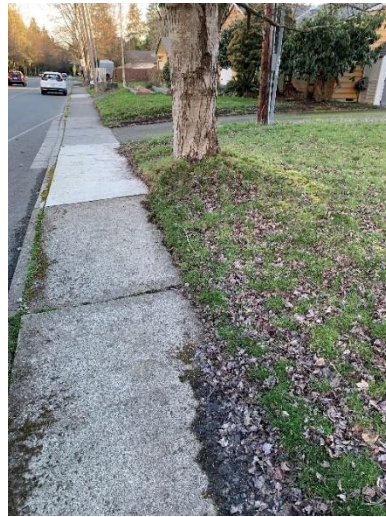
Figure 66. Minor impact to the existing sidewalk.

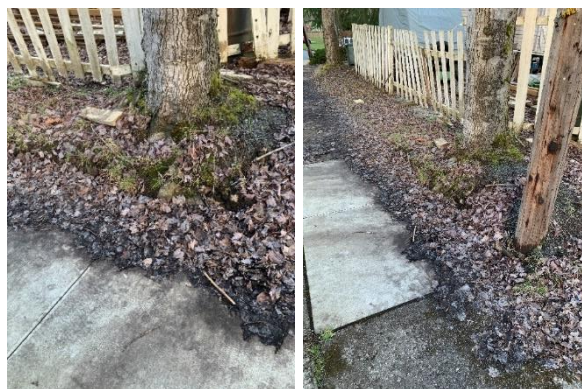
Figure 67. Minor impact to the existing sidewalk.

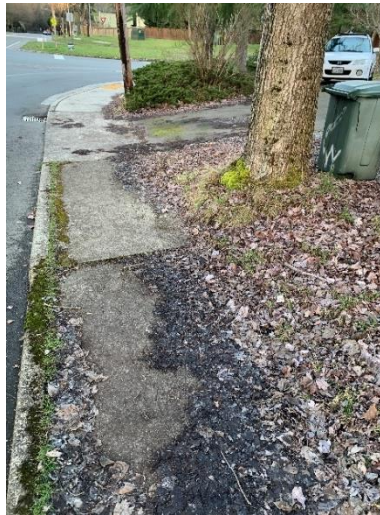
Figure 68. Minor impact to the existing sidewalk.

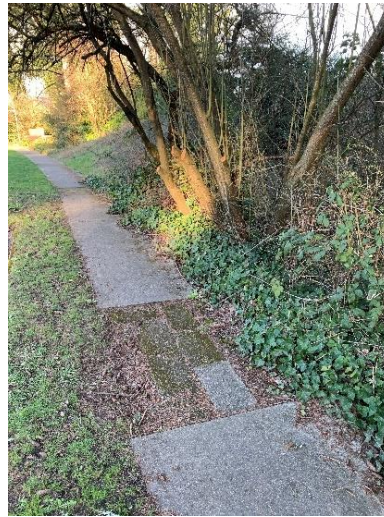
Figure 70. Multi-stem bitter cherry that should be removed and replaced with a more suitable species.
