March 25, 2022

Re: Arborist Assessment – 61st Ave NE Sidewalk Project

The Watershed Company Reference Number: 211037.2

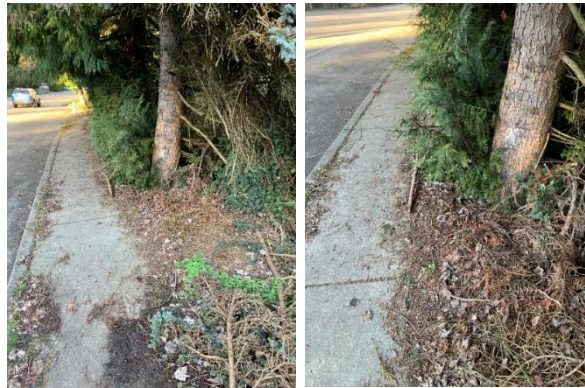
Advantages of Alternative Designs 3A and 3B: Allow for the retention of the significant tree.

Figure 69. Tree #222 located in a natural area away from the existing sidewalk.
